7. A New Road Safety Issue

7.1 The New Location of Turbine 1

7.2 The Safe Road Design Team Technical Note (May 2007)

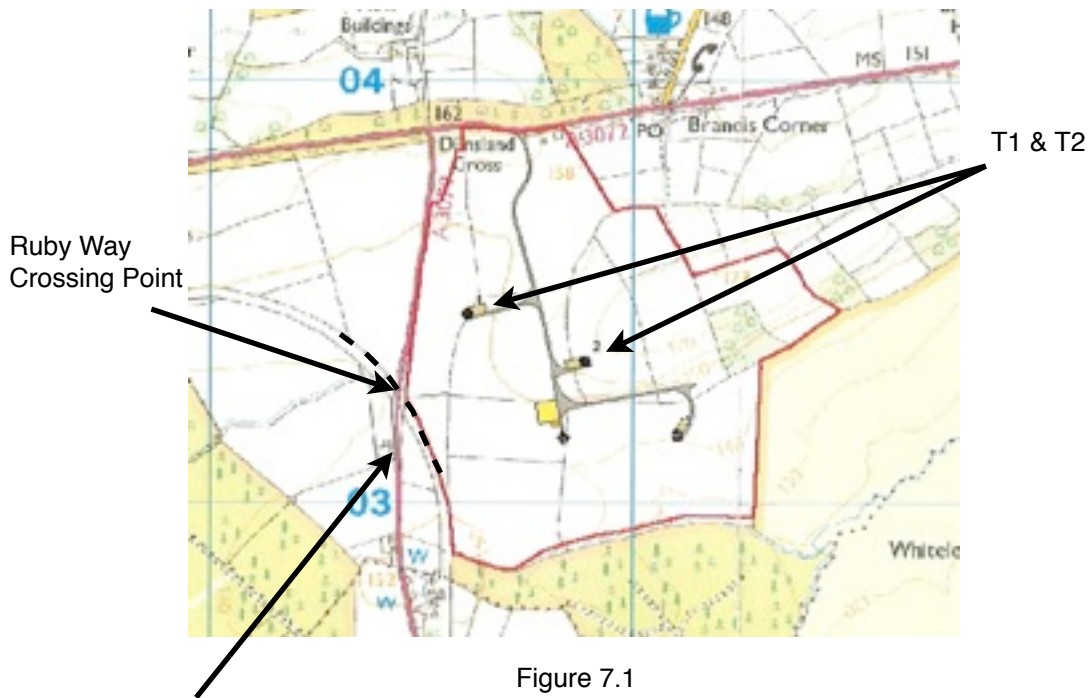
7.2.3 This is exactly the situation which arises at the Ruby Way crossing point at Dunslund Cross. The map below in Figure 7.1 shows the point of concern:

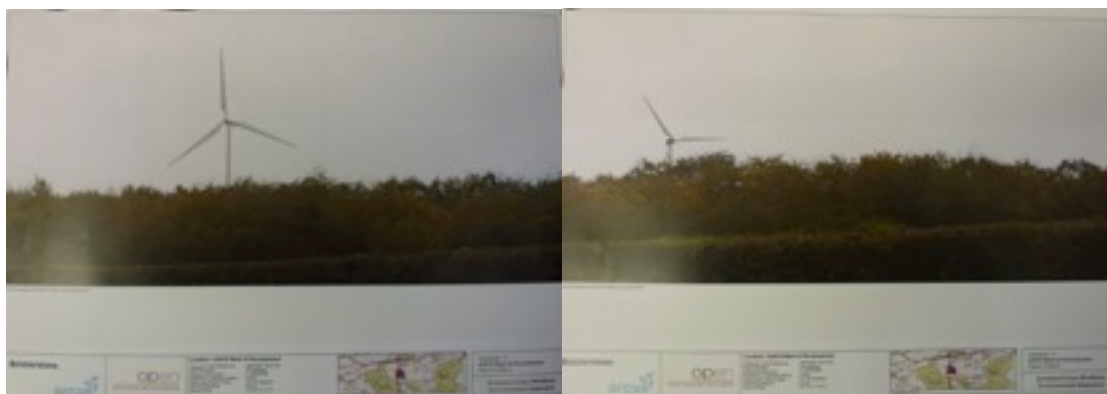
Position from where Applicant's photomontage Fig. 5.26a (1) & (2) was taken. (240432E 103113N)

7.2.4 It is not possible in this A4-size report to reproduce accurately the applicant's ES Photomontage Figures 5.26a (1) & (2) as they extend across two full A3 sheets. The reader must, however, view the actual photomontages, rather than rely on the thumbnails above, to gain a true understanding of the magnitude of the distraction awaiting drivers travelling North at this point. It is approximately 150 metres further on to the Ruby Way crossing point, or just over 6 seconds for a vehicle travelling at the typical 50 mph road speed for this stretch of the A3079.

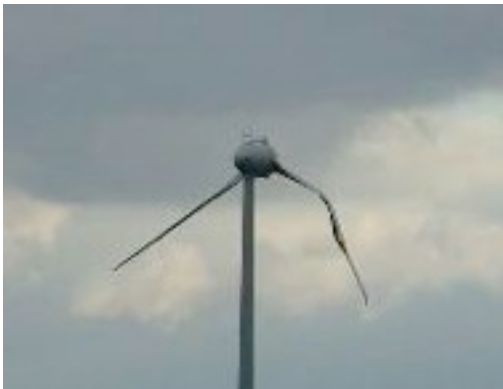
Louth, Lincolnshire, January 4th, 2009. The blades hit the Ecotricity Enercon turbine tower and one was thrown clear.

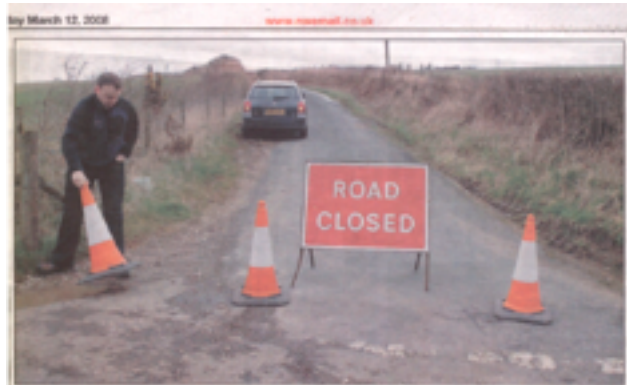
SAFETY FIRST: Pease Loke, in Morton, is closed off following the recent gale force winds
Exclusion zone around wind farm after gales

By NATALIE CHAPPELLE
natalie.chapelle@journal.co.uk
A New exclusion zone is in place around a Furness wind farm after gale force winds battered Cumbria.
Pease Loke in Morton has been closed off since Monday evening as engineers work to fix a mechanical failure on a turbine at Askham and Drith Wind Farm.
Power Generation PLC requested that a section of the area be a safety precaution before the scheduled high winds arrived.
Peter a spokesman for E.ON said: "Because of the weather we are engineering our turbines to be able to carry out the work."
E.ON said the road block may be in place until Friday.
The spokesman said: "It's a safety precaution."

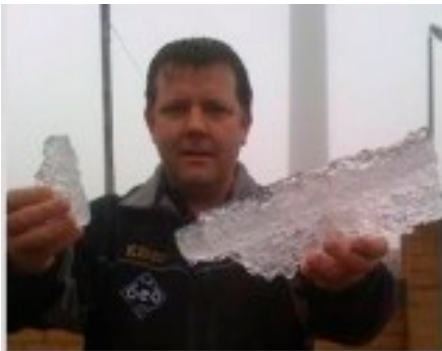
December 2008: Mr. Tyson Clark with some of the ice which fell off the 125m Vestas V90 turbine at Whittlesey.

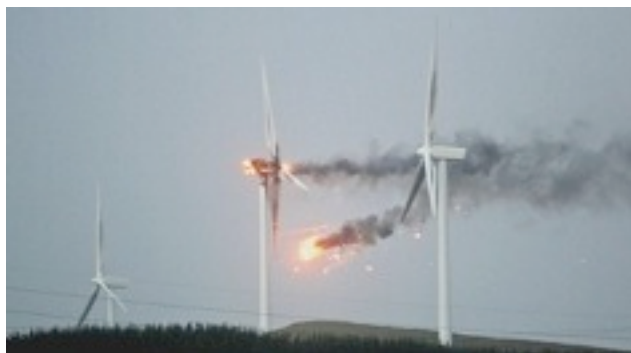
December 2011: Blazing debris is scattered from a turbine on fire at the Ardrossan Wind Farm in Ayrshire.
